SEPTEMBER 16, 2024

MUNICIPALITY OF TOA ALTA AUGUST 2024  
MONTHLY REPORT  
Civ. No. 3:21-01087-DRD

NIVIA I. AYALA, PE  
TERRATEK ENGINEERING GROUP, PSC  
P.O. Box 367445 San Juan, PR 00936

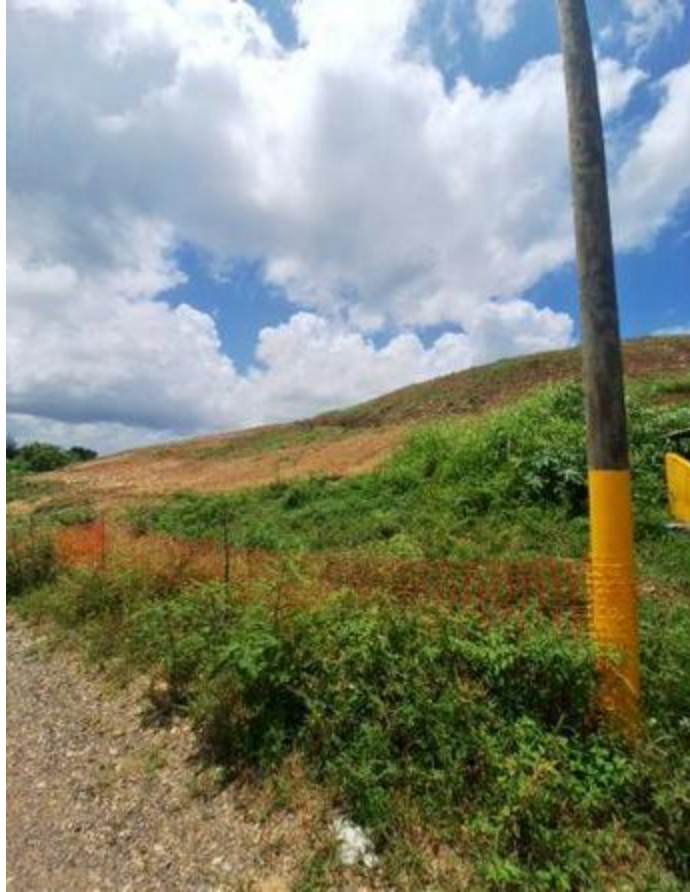
###### **Daily Cover:**

Daily Cover at the facility was completed on April 30, 2022. Daily Cover covered all areas of exposed waste.

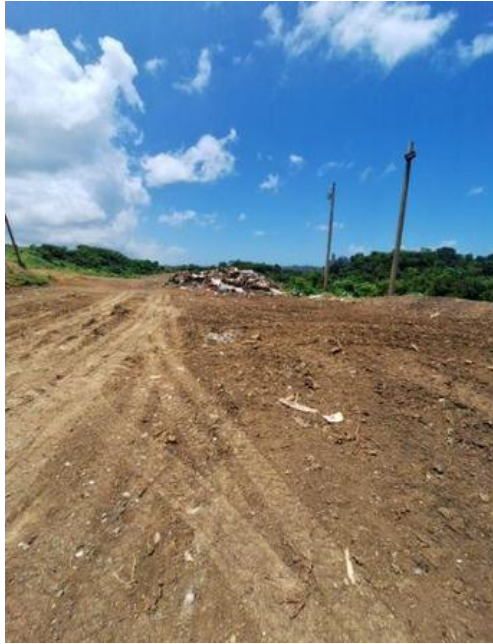
**Cessation of Waste Disposal:**

The cessation of waste disposal at the facility was completed by March 30, 2022. However, as agreed in the Stipulation, the temporary storage of construction and demolition (C&D) waste, bulk household waste (durable goods such as mattresses, furniture, and appliances), or yard waste (vegetation waste generated by land maintenance) for final disposal at a different landfill is active and been performed daily.

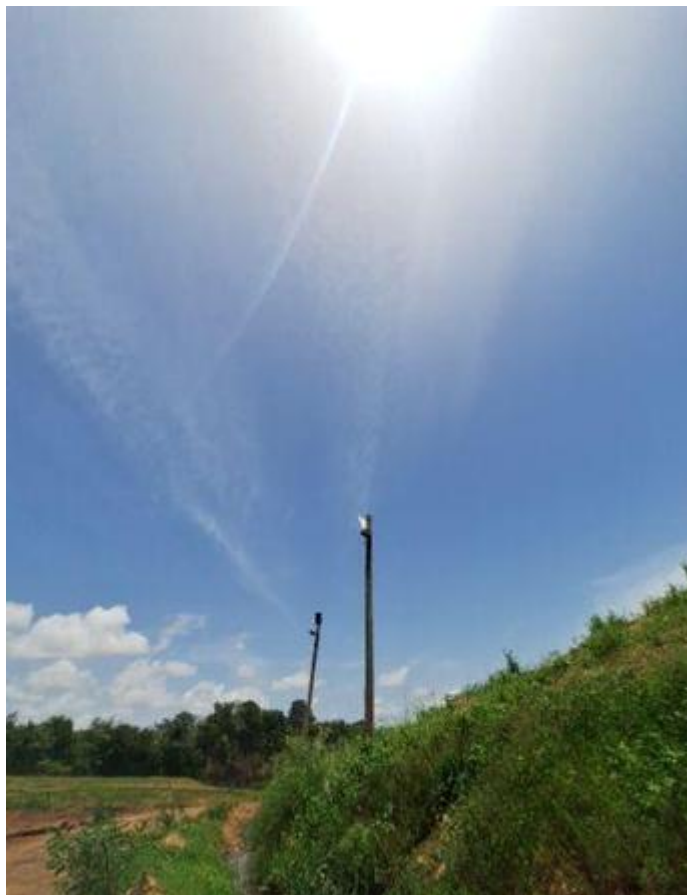
Incluir Foto de los datos del pluviometro

Los datos registrados por el pluviometro son reportados a las oficinas pertinentes del municipio de Toa Alta. Hoy la lluvia acumulada es 0 pulgadas.

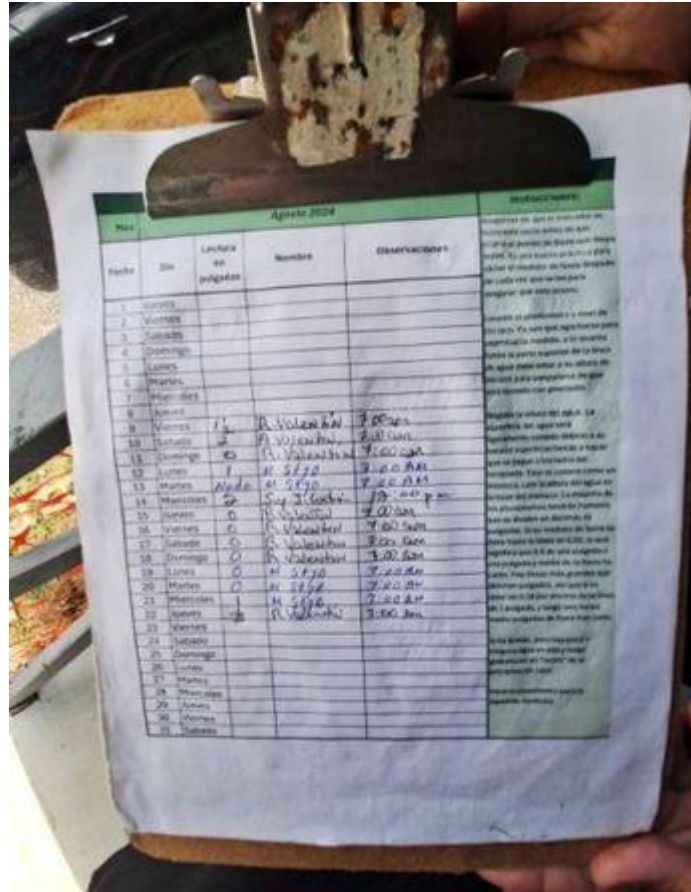
Incluir Foto de los datos del pluviometro

Los datos registrados se reportan diariamente a la administracion del SRS y se llevan anotados según constata la imagen anexa.

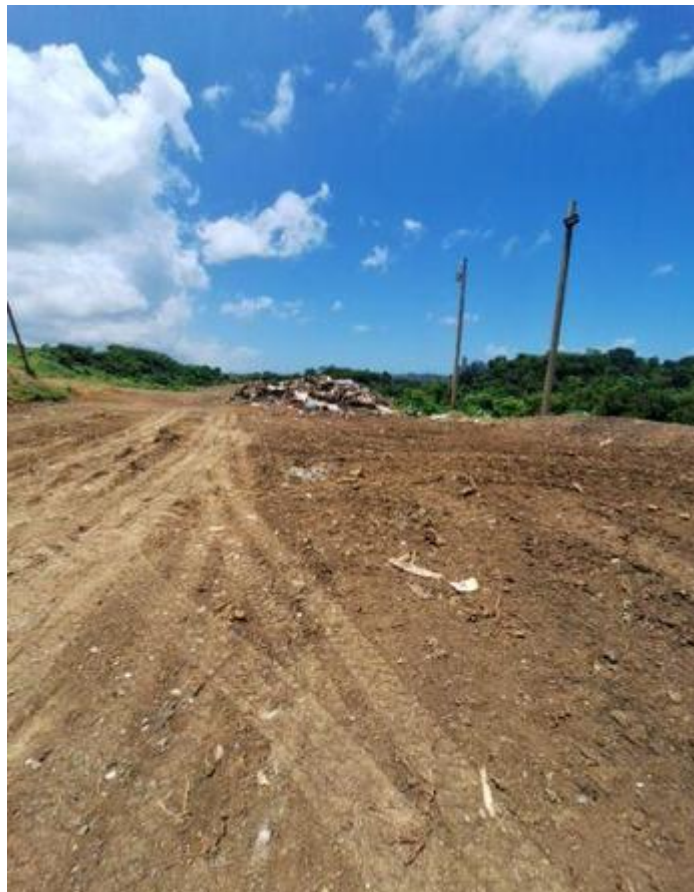
Tomar foto de la estacion de trasbordo

Condicion Operacion Recibo de Escombros

Necesita Limpieza

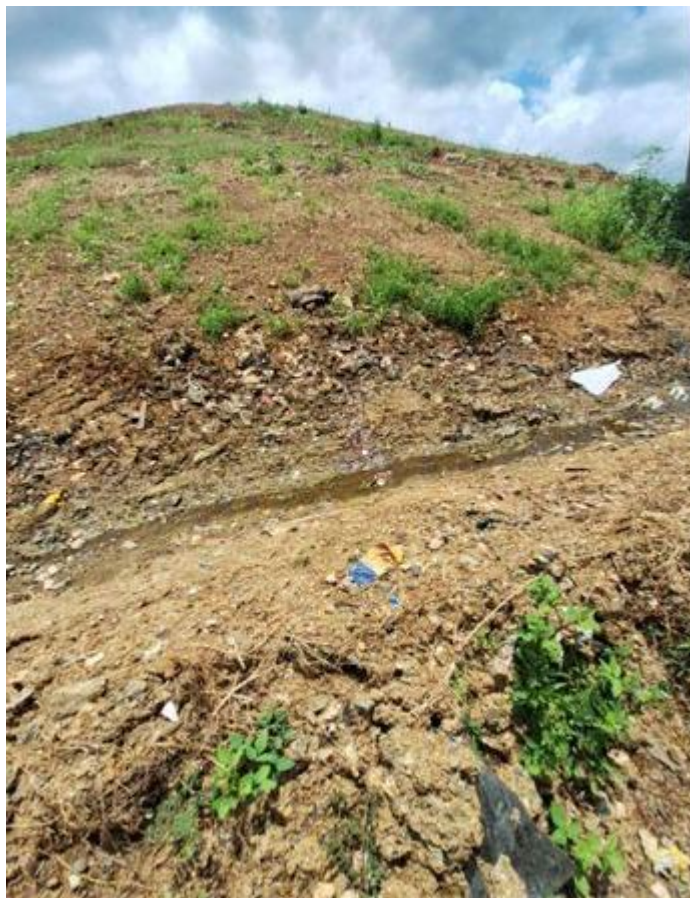
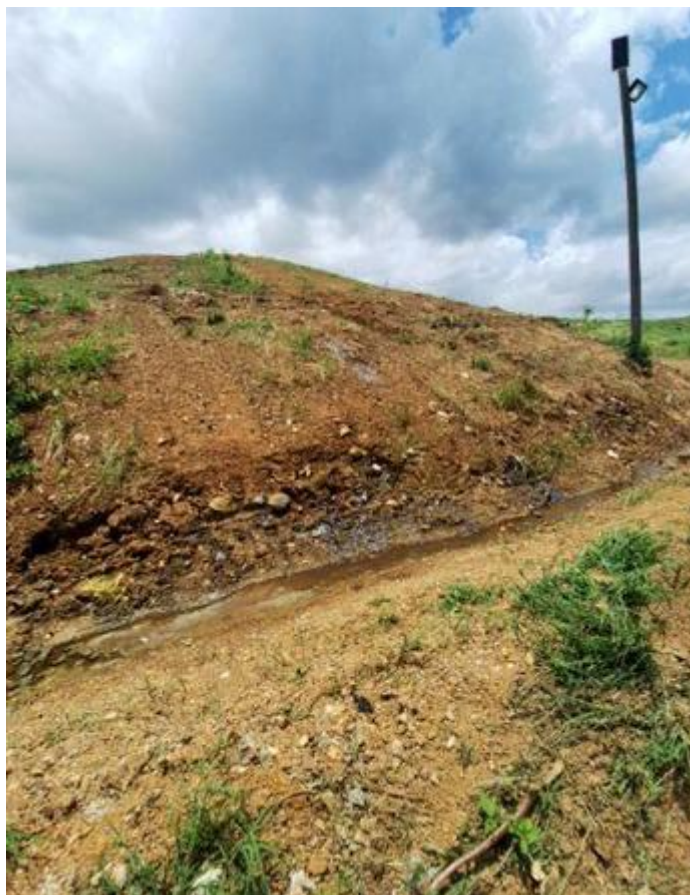
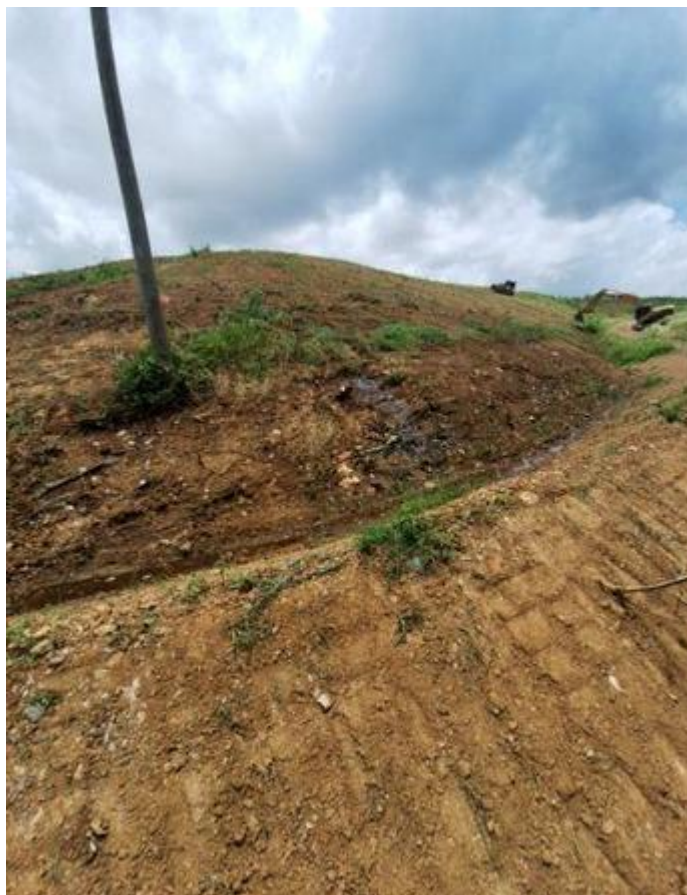
Añadir fotos deal area de  
brotes visibles

Se pueden notar brotes de  
lixiviado?

SI

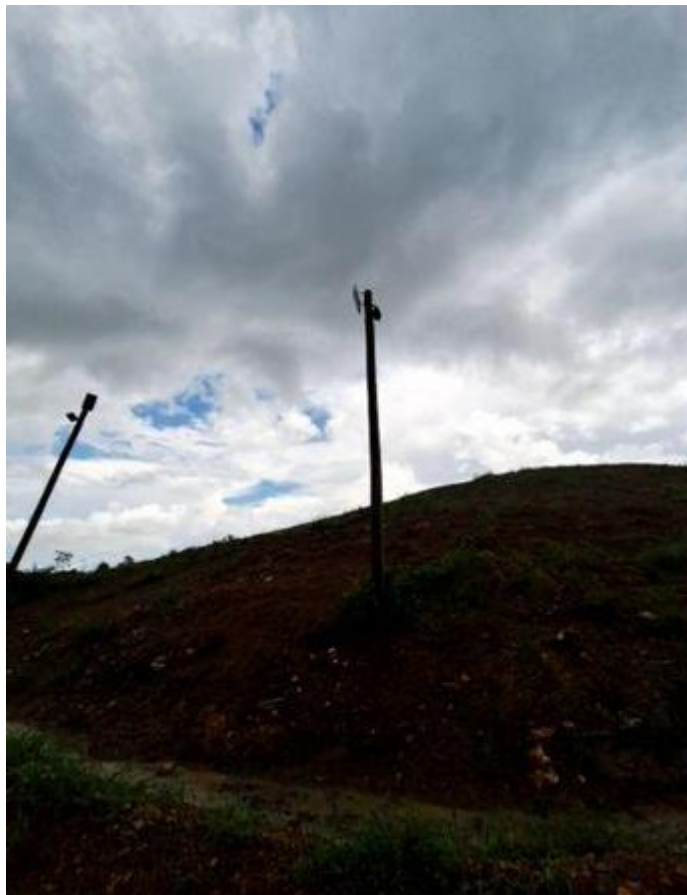
Incluir Foto de los datos del pluviometro

Los datos registrados de precipitación se reportan a la oficina administrative del municipio. El día de hoy se reportan 1.5 pulgadas.

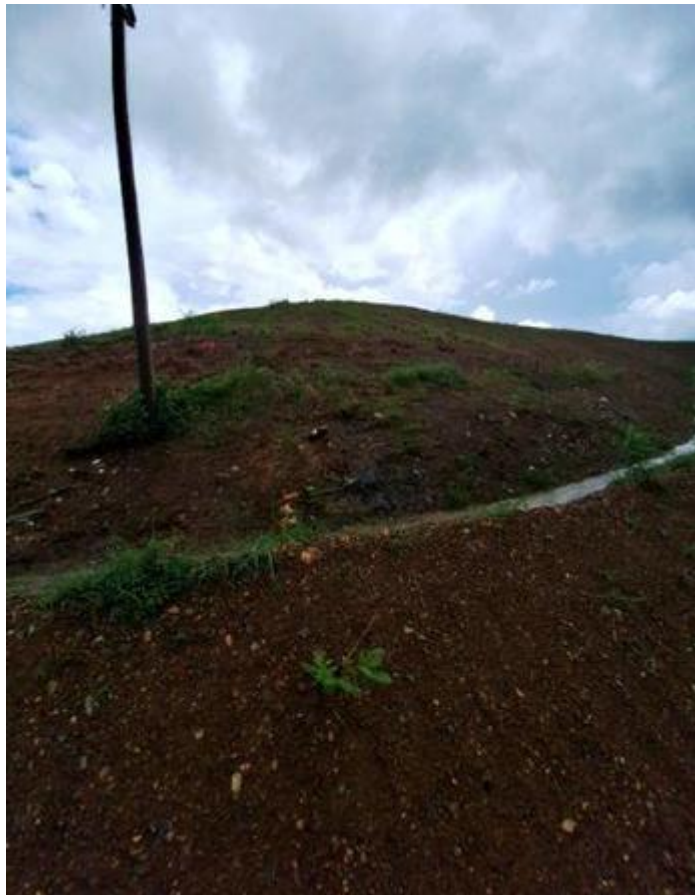
Tomar foto de las pendientes y la vegetacion

Condicion Operacion Recibo de Escombros

Necesita Limpieza

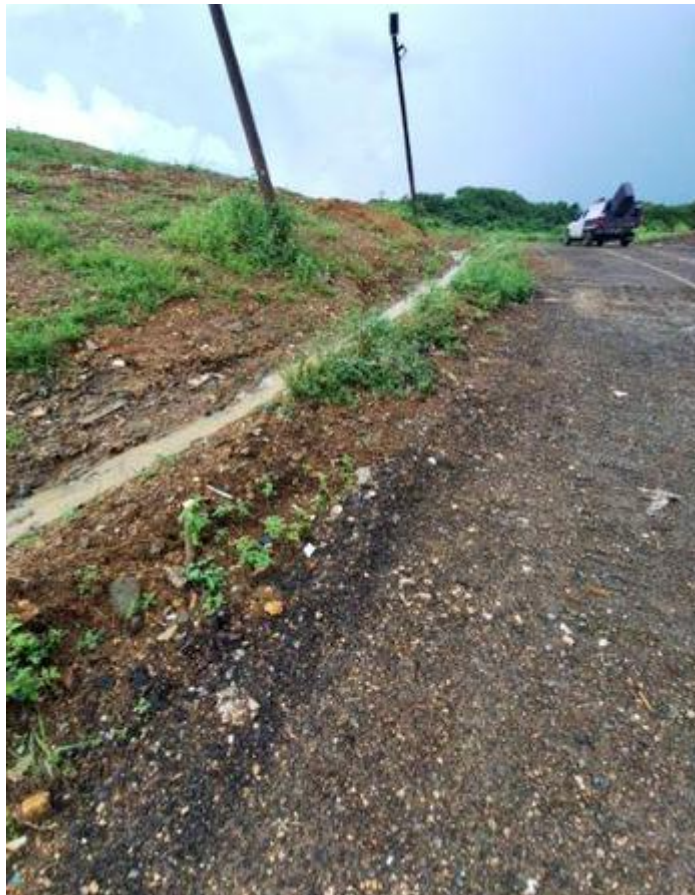
Tomar foto de las medidas de control (bermas, piso, etc.)

Equipos Operando

Al momento de la inspección un D4 y una retroexcavadora.

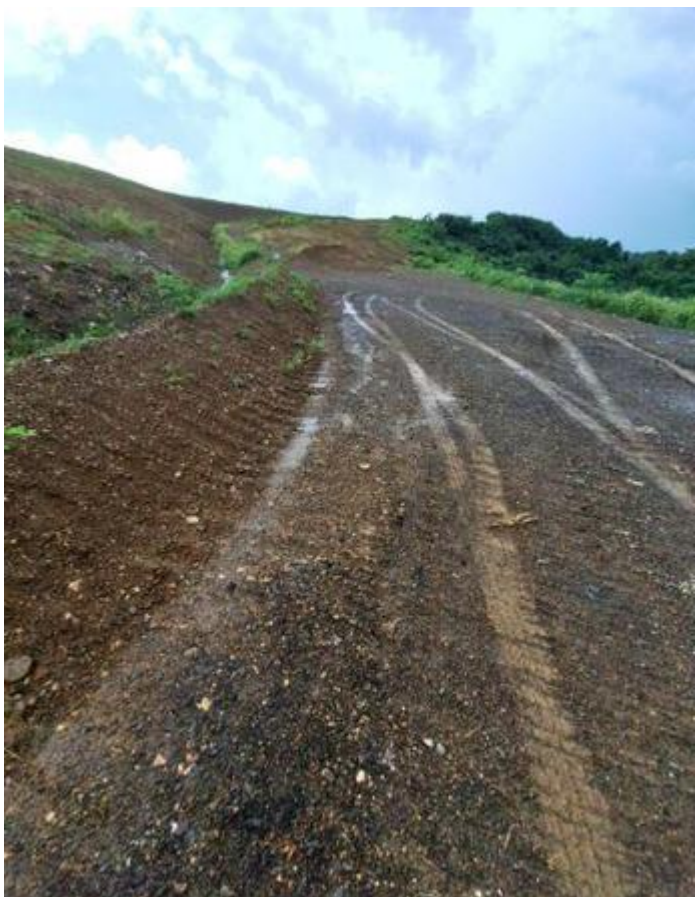
Excelentes condiciones

Añadir fotos sobre las  
condiciones del camino  
perimetral.

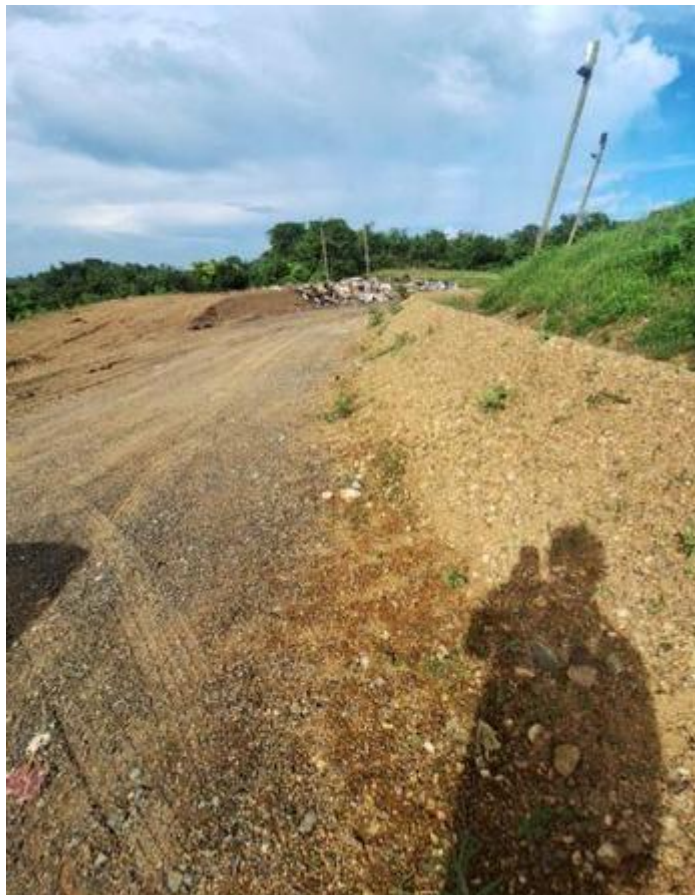
Condicion Operacion Recibo de Escombros

Buena

Tomar foto de la estacion de trasbordo

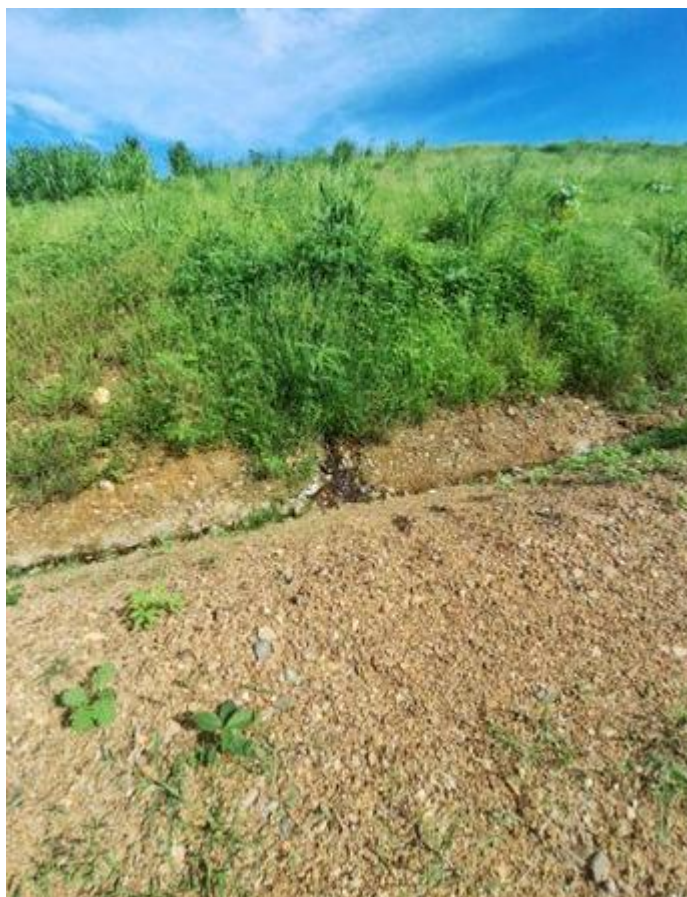
Se pueden notar brotes de  
lixiviado?

SI

Añadir fotos deal area de  
brotes visibles

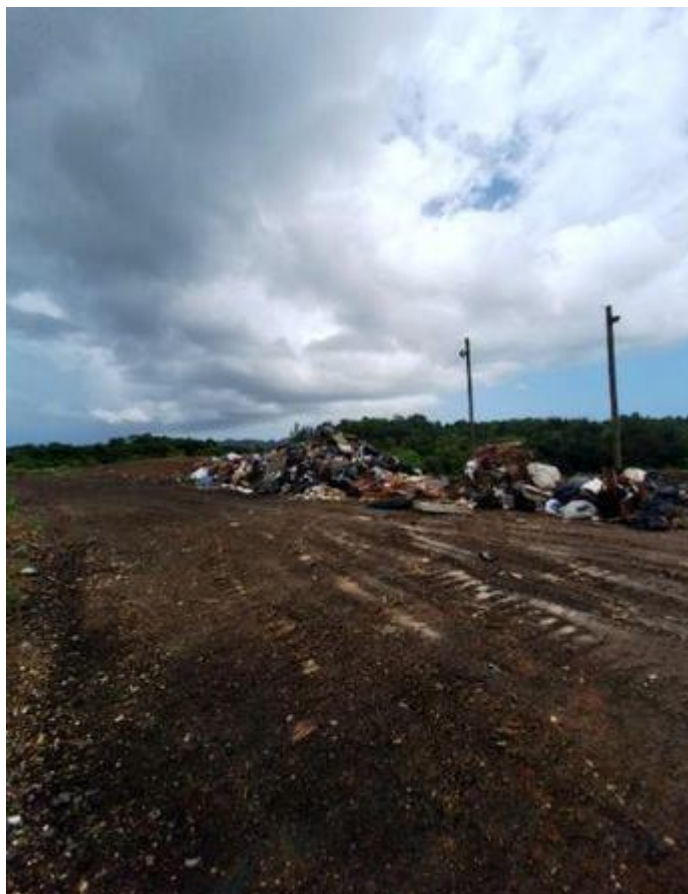
Condicion Operacion Recibo  
de Escombros

Necesita Limpieza

Tomar foto de la estacion de  
trasbordo

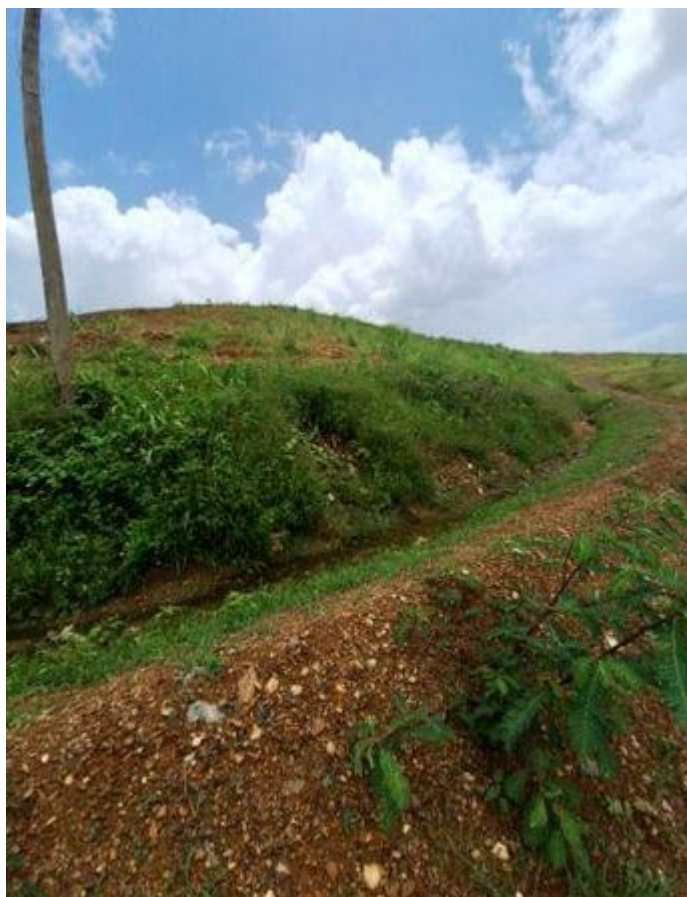
Se pueden notar brotes de  
lixiviado?

SI

Añadir fotos deal area de  
brotes visibles

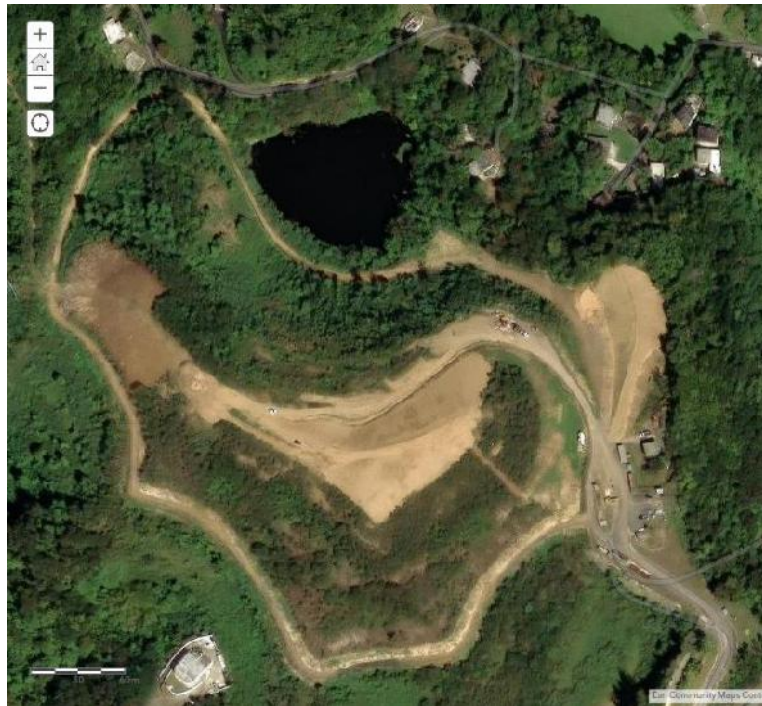
*Figure 5 Aerial View*

This picture shows the successful implementation of stormwater control measures. There is no evidence of sediment or erosion leaving the property boundaries or being dragged through areas within the Site. This success should reassure you about the effectiveness of our plan. Nevertheless, we acknowledge that additional control measurements will be needed at specific outfalls from the southeast side of the property.
